# Volvo D2-75 Turbo: Soot Cleaning and Carbon Burn Data

## Introduction

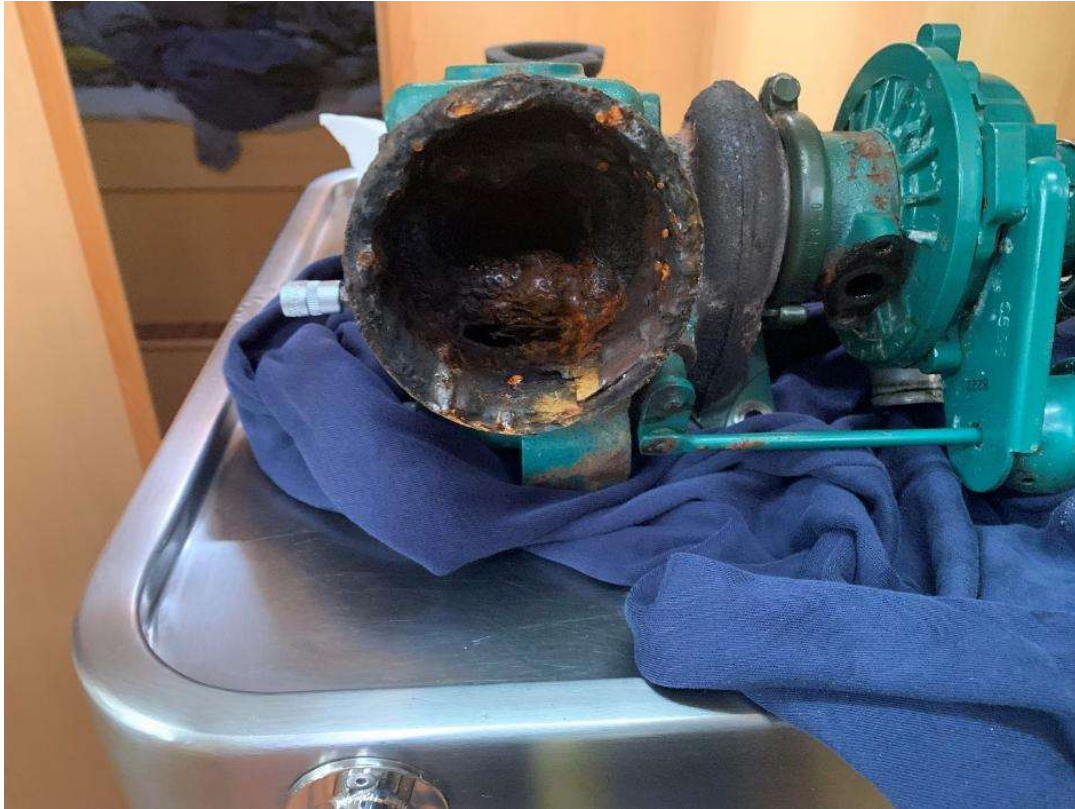
Dismounting the original Volvo iron cast elbow, we could see right away that its exhaust side connected to the exhaust tube and the waterlock was seriously corroded. The exhaust side after the water injection looked like it had spent a century underwater. Therefore, it was time to change it by a new one in inox.

Severely Corroded Exhaust Elbow After Water Injection.

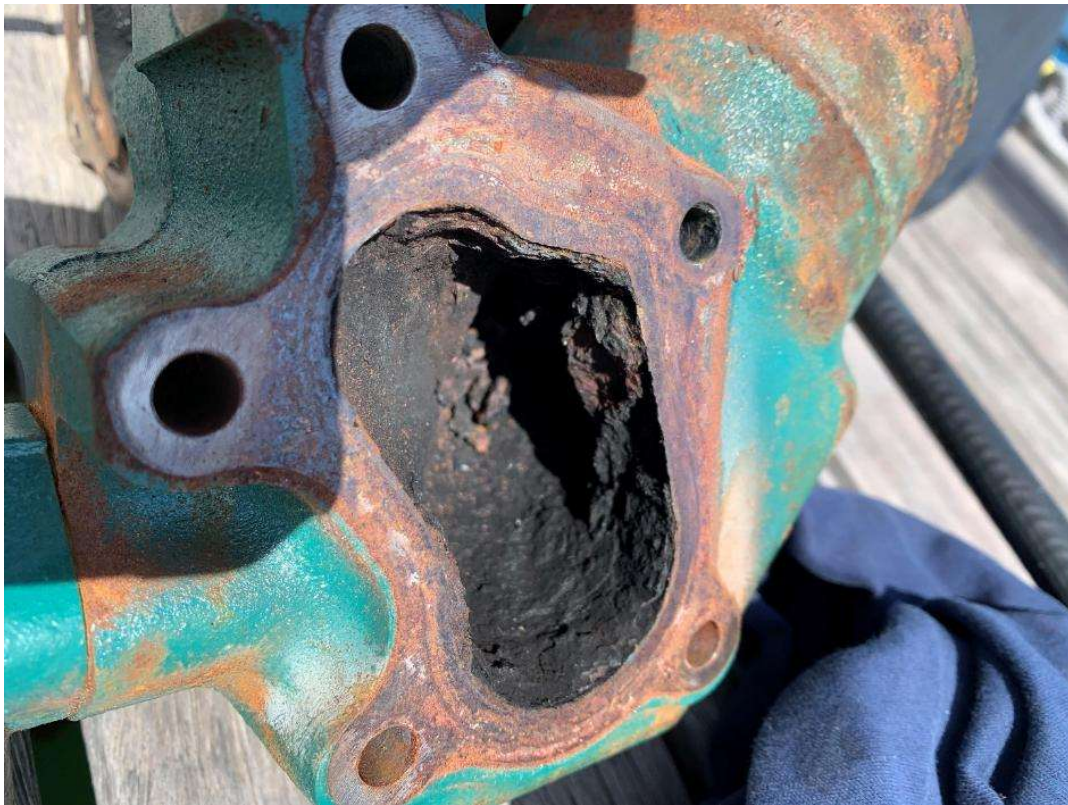
Severely Corroded Exhaust Elbow Turbo Hot Outer Chamber Side.

We initially just wanted to replace the exhaust elbow but discovered that our turbo wastegate was jammed shut solidly. In addition, the inside of the turbo exhaust outside chamber, that connects to the elbow, was severely corroded as well. Why?

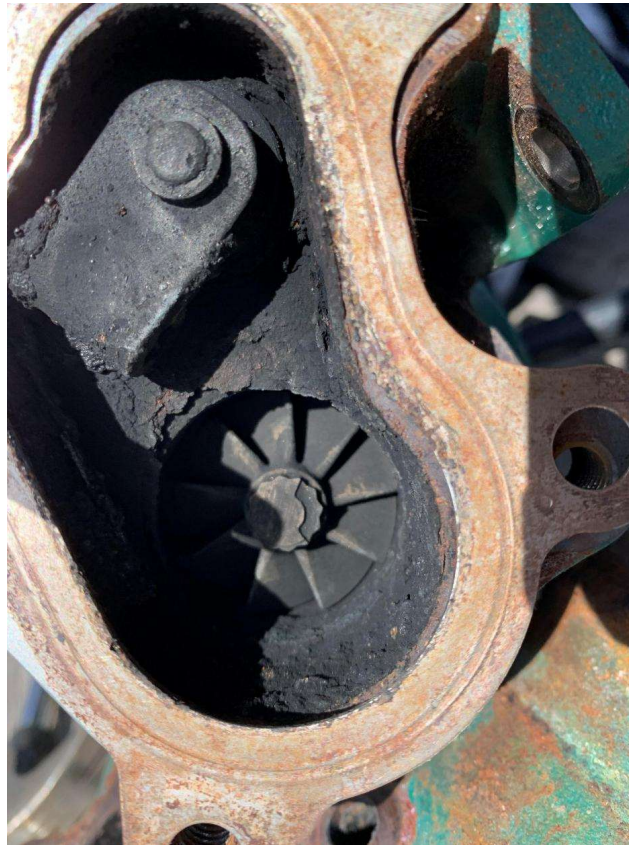
Outer Chamber of the Turbo After the Turbine and the Turbine. Note the heavy Corrosion near the Turbine which Impedes its Rotation a Little.

- 5) Corrosion in the part where the exhaust turbine of the turbo is located also lead to a slight impairment of the turbine rotation on the corrosion burrs.

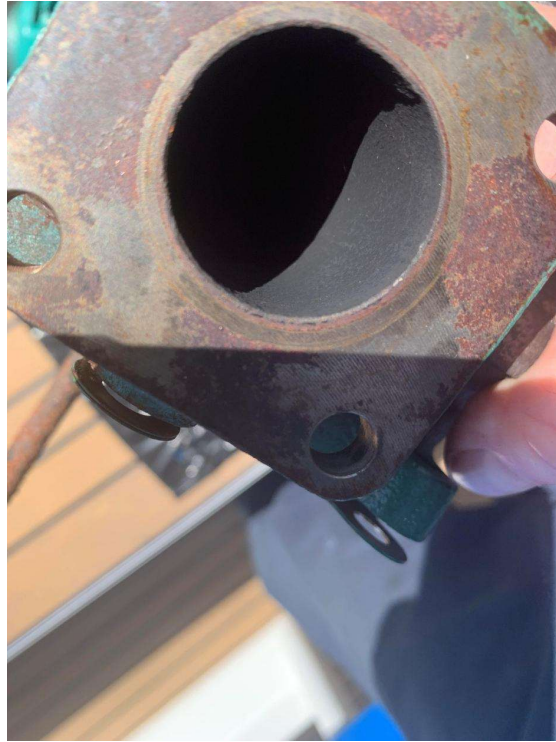
Turbo Exhaust inside Chamber Before the Turbine1. No Soot Accumulation there.

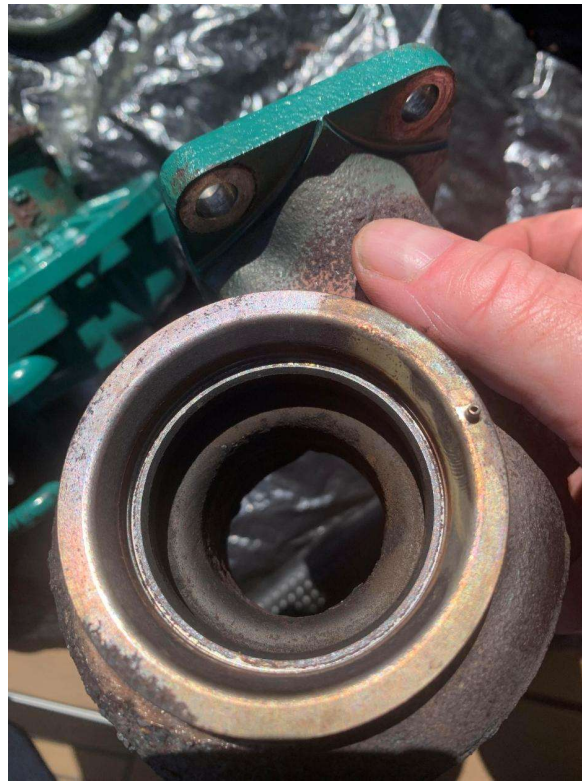
Turbo Exhaust inside Chamber before the Turbine 2. No Soot Accumulation but Corrosion Where the Turbine let the Hot Gaz into the Elbow. Please note also the alignment pin.

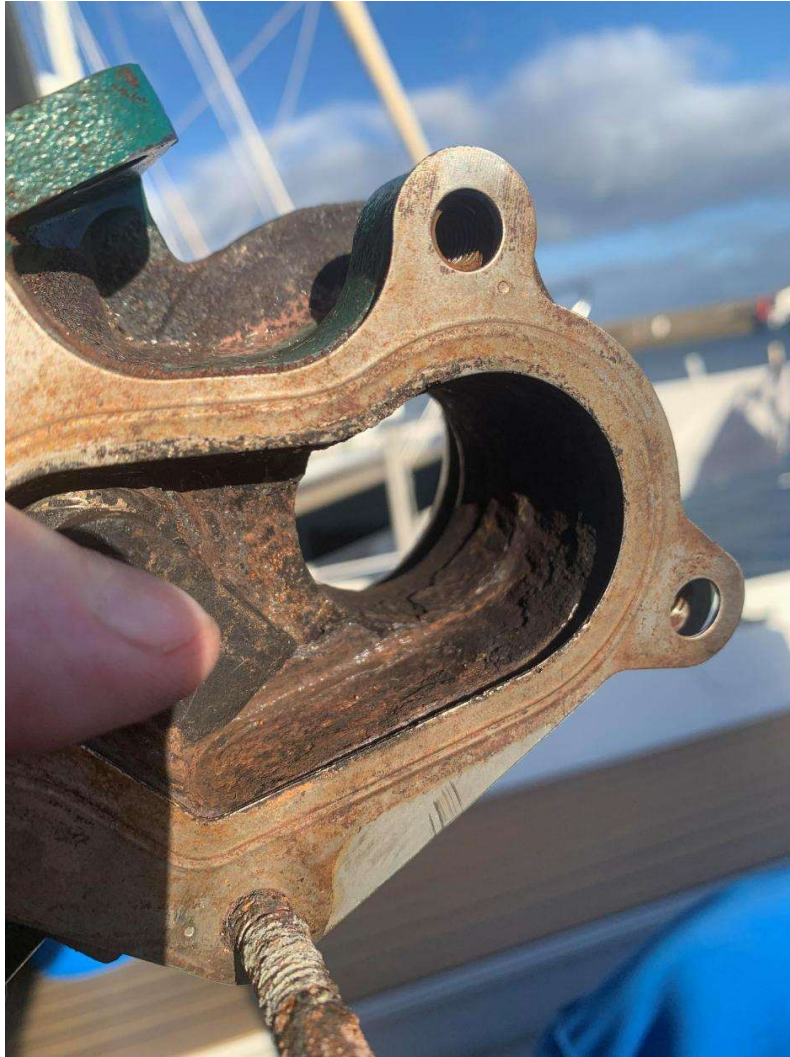
Turbo Exhaust outer Chamber before the Turbine 3. Heavy Corrosion Burr where the Turbine lets the Hot Gaz into the Elbow.

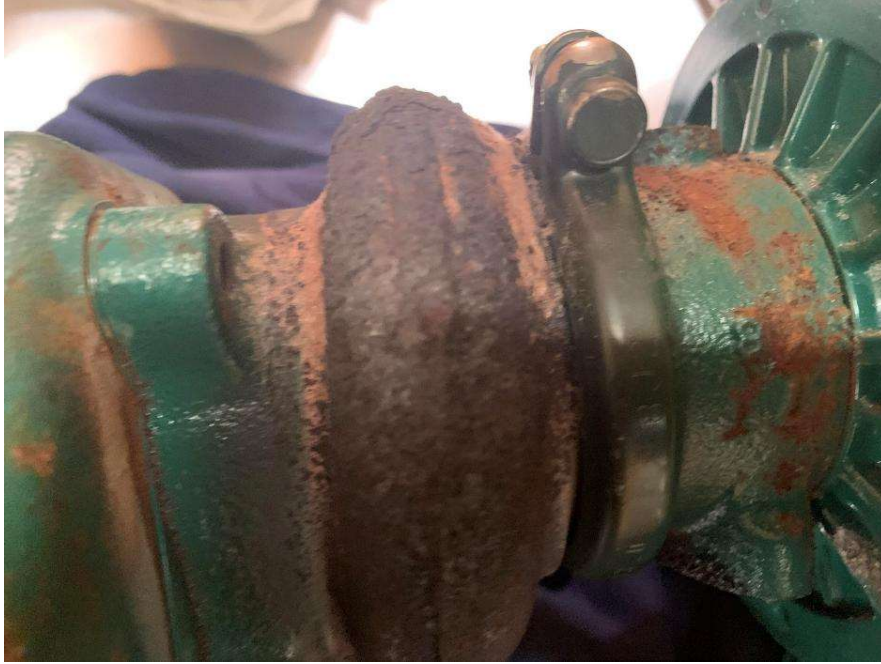
Furthermore, the outside casing of our turbo had a lot of rust. During Fabule's test sail with Boréal, a wrongly mounted seal of the dagger board casing had caused the ingress of a huge amount of salt water, which made its way from the lazarette to the engine compartment and to the bottom of the boat. Salt water got splashed everywhere by the Vetus Coupler who was bathing in salt water: it splashed on the engine chamber, on the engine, and more particularly soaked the thermal blanket over the hot part of the turbo. This explains why the outer part of the turbo casing became a rusty piece of iron.

Rust Bucket Turbo Housing on the Hot Side.

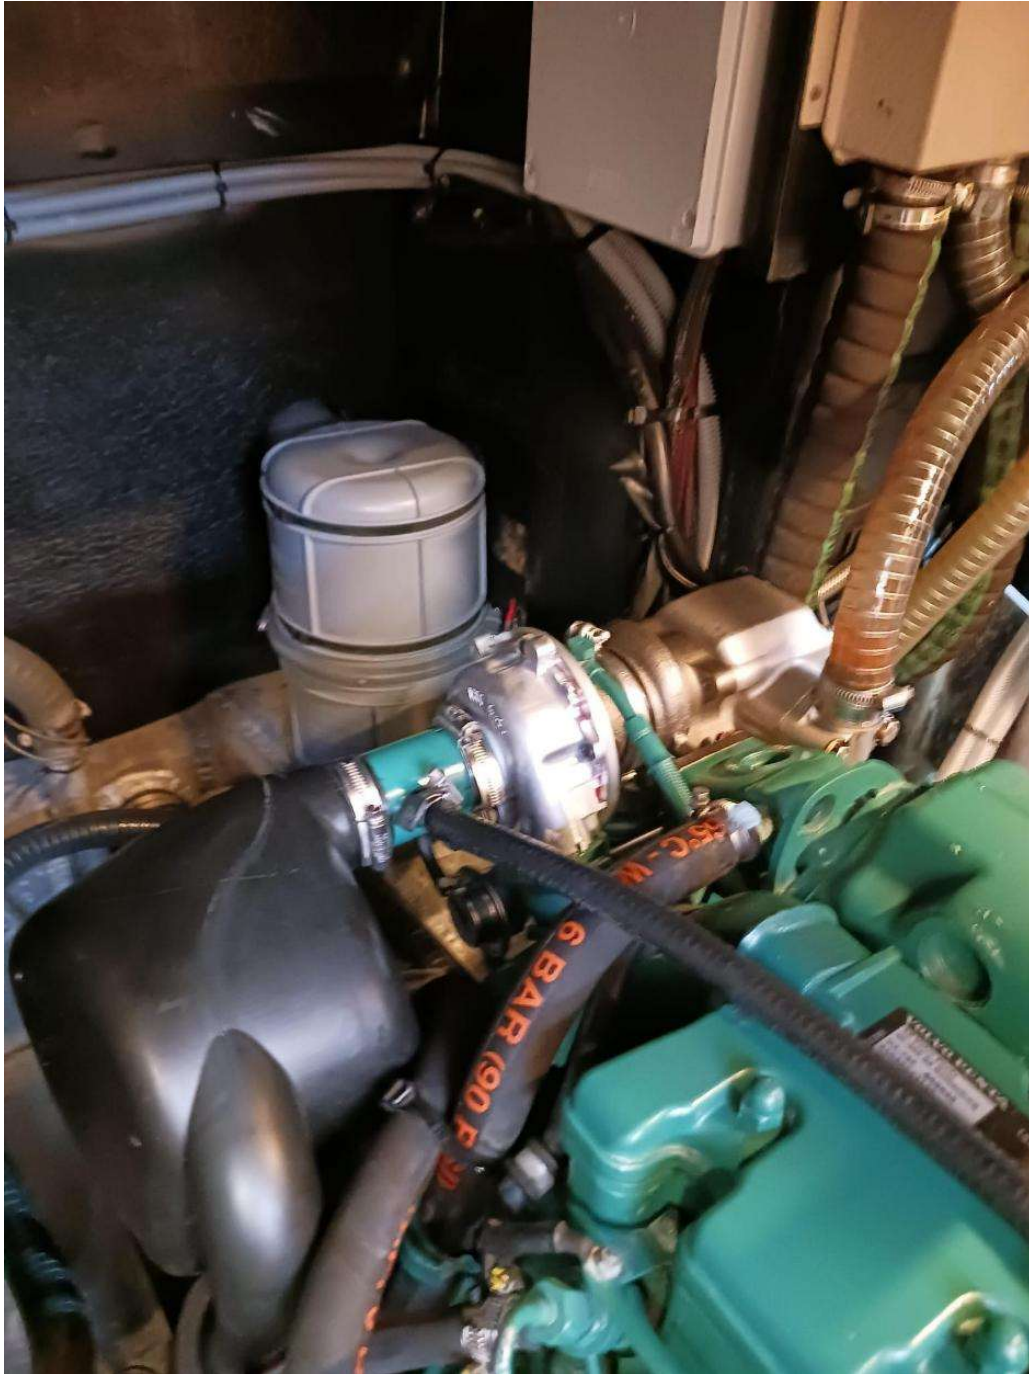
Spiffy New Turbo Mounted on the Engine. Note the Inox Exhaust Elbow.

Mounting the new turbo on the engine was easy. One key point is to inject engine oil on top of the turbo oil intake and to turn it by hand to spread some oil in the turbo bearings to lubricate them, before connecting in intake turbo oil line to the turbo. They graciously provide a syringe in the assembly bolt and nuts kit (sold separately) for that. Furthermore, IHI, which manufactures these turbos for Volvo, recommended to run the engine in idle for at least 10 minutes, so that a nice flow of oil comes lubricating the bearings before making the turbo work harder and hotter.

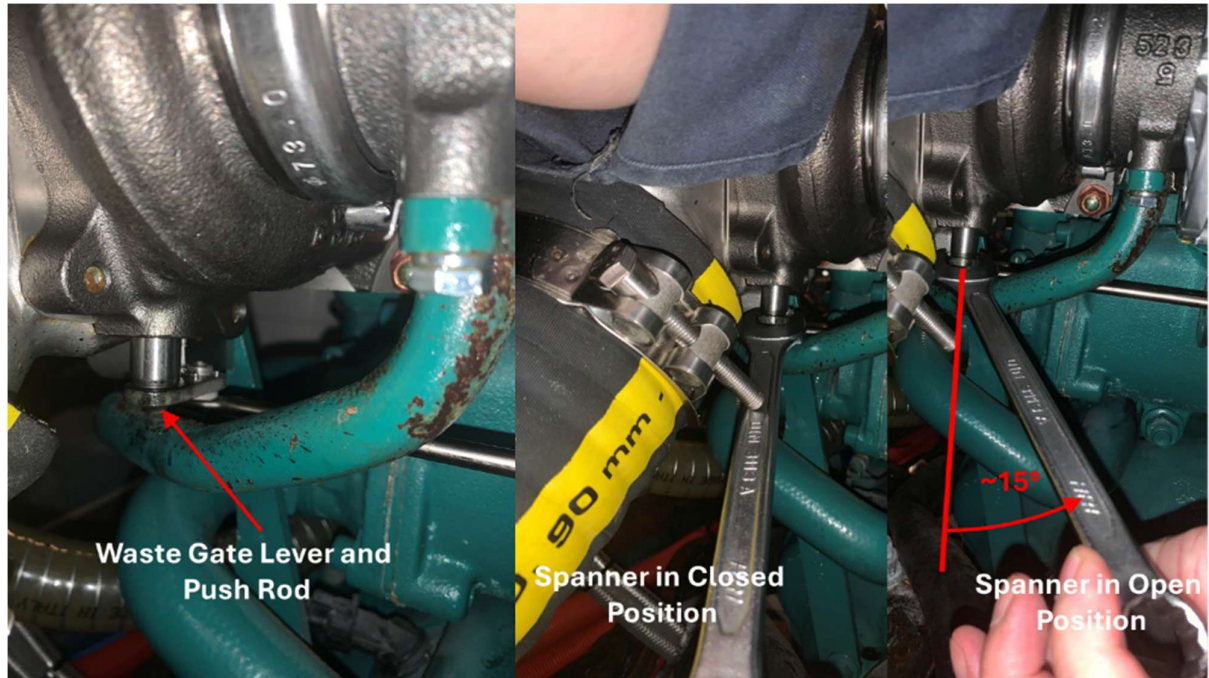
Exercising the wastegate from Time to Time. Direction of the Gate Opening. About 15 degree movements only.

- 1) Approximately 5 hours at whatever RPM we need. If they are lower than 2300-2400 RPM, we plan to modify the carbon burn as follows:
  - a. Above 2300 RPM for 20-30 minutes,
  - b. 10 minutes above 2700 RPM to open the wastegate.
- 2) From time to time we will verify the correct opening of the wastegate with a **16mm spanner** or a wrench. See the picture below for the movement of the gate opening.

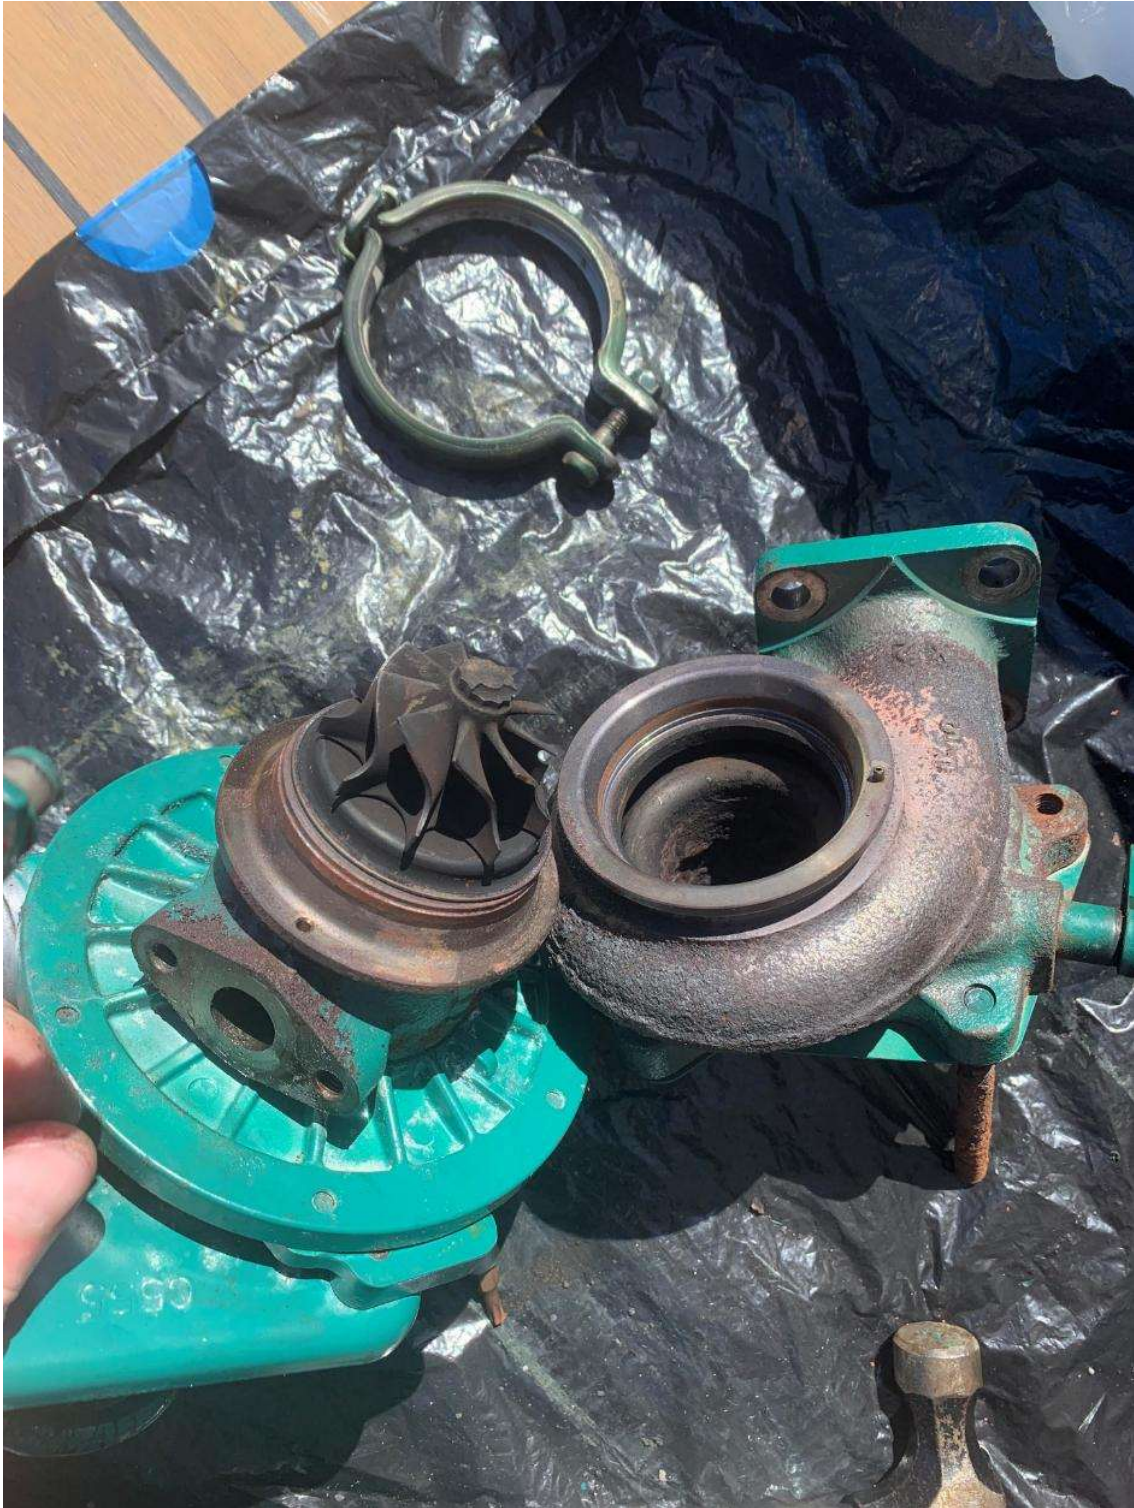
Opened Turbo Exhaust Chamber. Please note the alignment hole and pin in the assembly to accurately remount it after cleaning.

- 3) Remove the C-clamp by untightening the screw, and open the hot part of the turbo to free the hot turbine from its chamber. (see picture) Be careful to not bump the turbine in the process, so pull open along the turbine shaft axis

- 4) Remove what needs to be removed, soot or corrosion burrs,
- 5) To remount the hot chamber on the turbine, use the alignment pin and hole (see picture), and remount the C-clamp.
