# Volvo D2-75 Turbo: Soot Cleaning and Carbon Burn Data

## Introduction

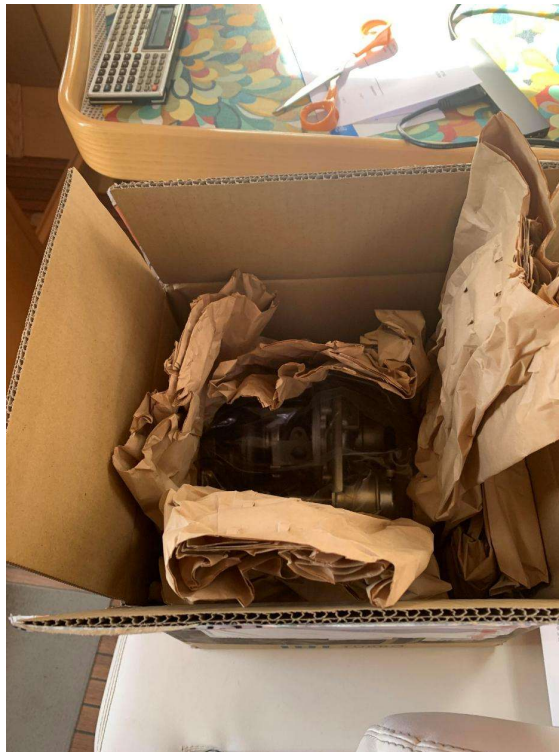
New Spiffy Turbo Assembly from MarineDustrie.

Mounting the new turbo on the engine was easy. One key point is to inject engine oil on top of the turbo oil intake and to turn it by hand to spread some oil in the turbo bearings to lubricate them, before connecting in intake turbo oil line to the turbo. They graciously provide a syringe in the assembly bolt and nuts kit (sold separately) for that. Furthermore, IHI, which manufactures these turbos for Volvo, recommended to run the engine in idle for at least 10 minutes, so that a nice flow of oil comes lubricating the bearings before making the turbo work harder and hotter.
